Extraordinary maintenance of the turbine exhaust duct

We have been commissioned by a major global leader in the production and sale of baking ingredients to carry out extraordinary maintenance on the turbine exhaust duct DN1400/1700, which is out of service due to incorrect design. This design flaw resulted in the rupture of the line in several places after only a few months of operation.

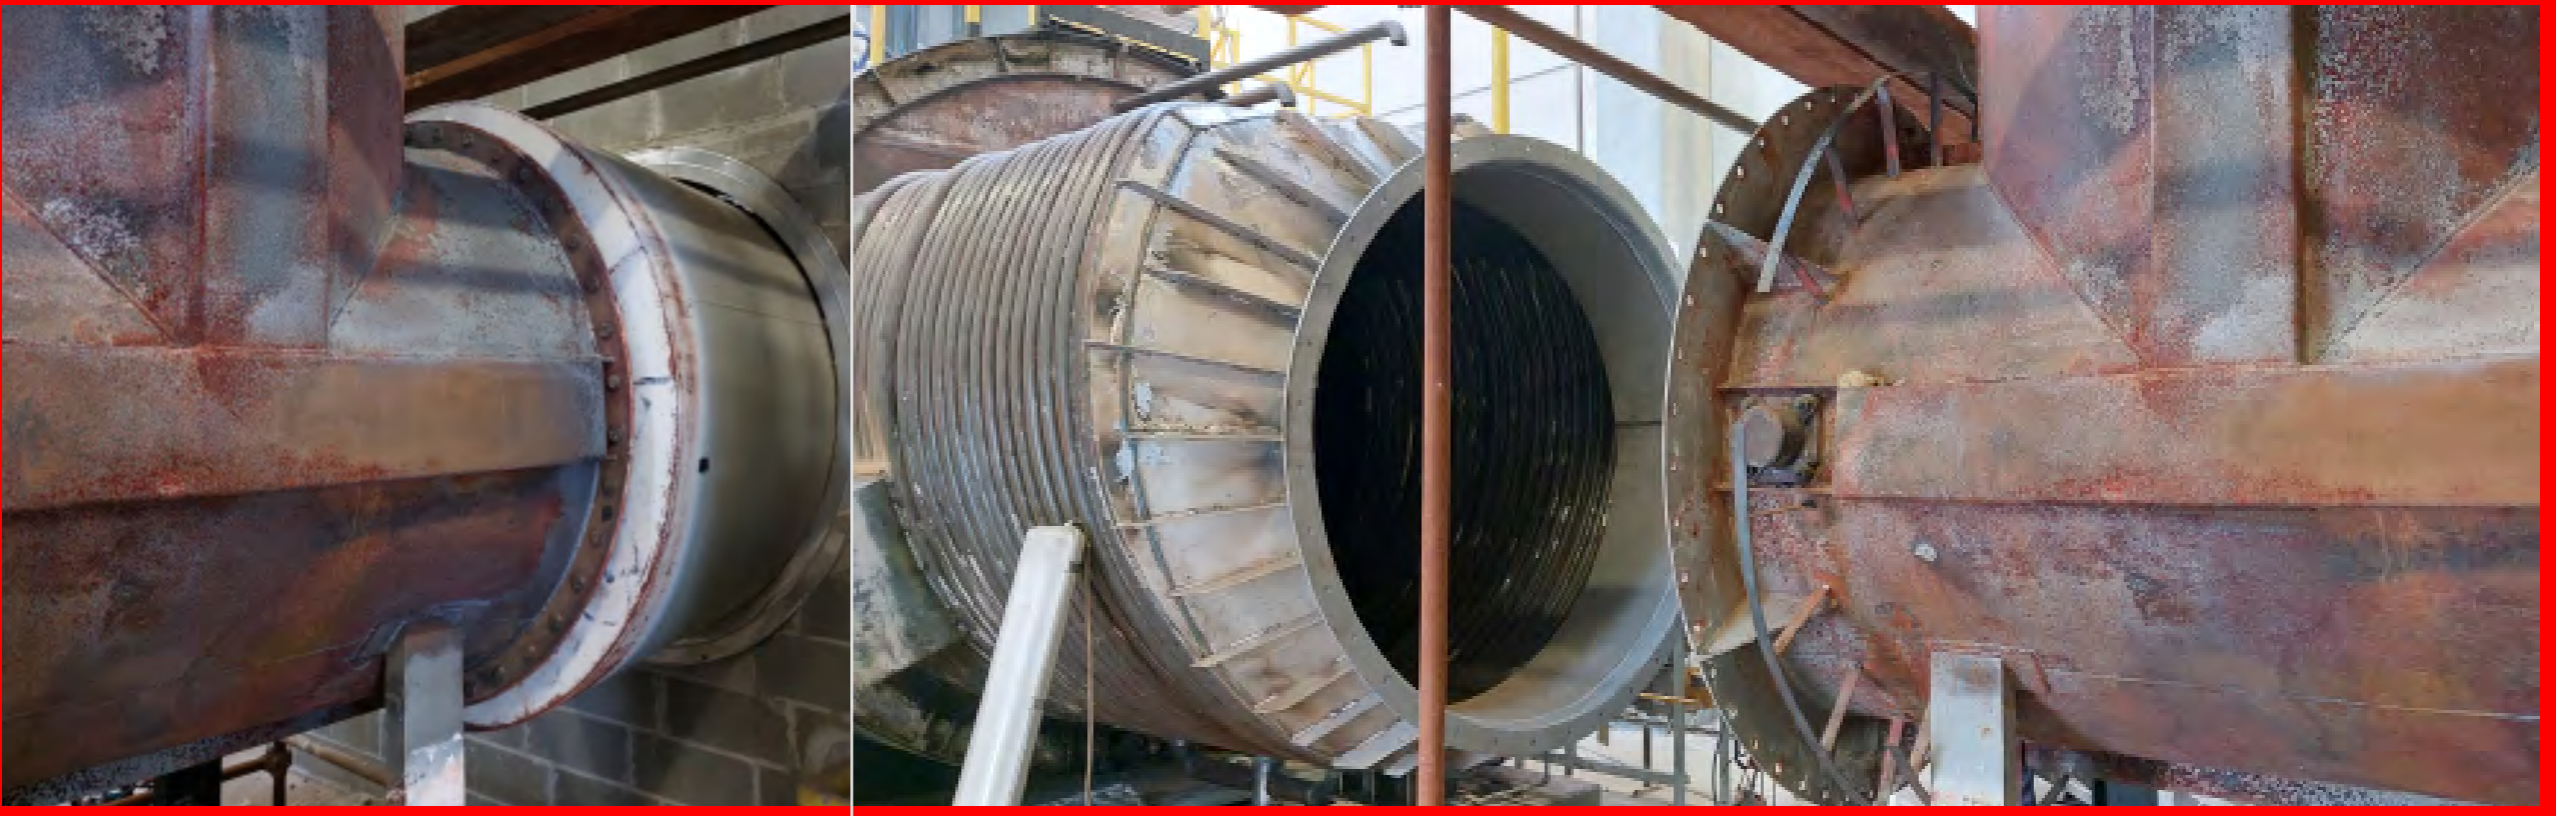
1

First, Giorgi Engineering conducted an on-site inspection to assess the current condition of the duct and to identify the main issues that led to the pipeline rupture.

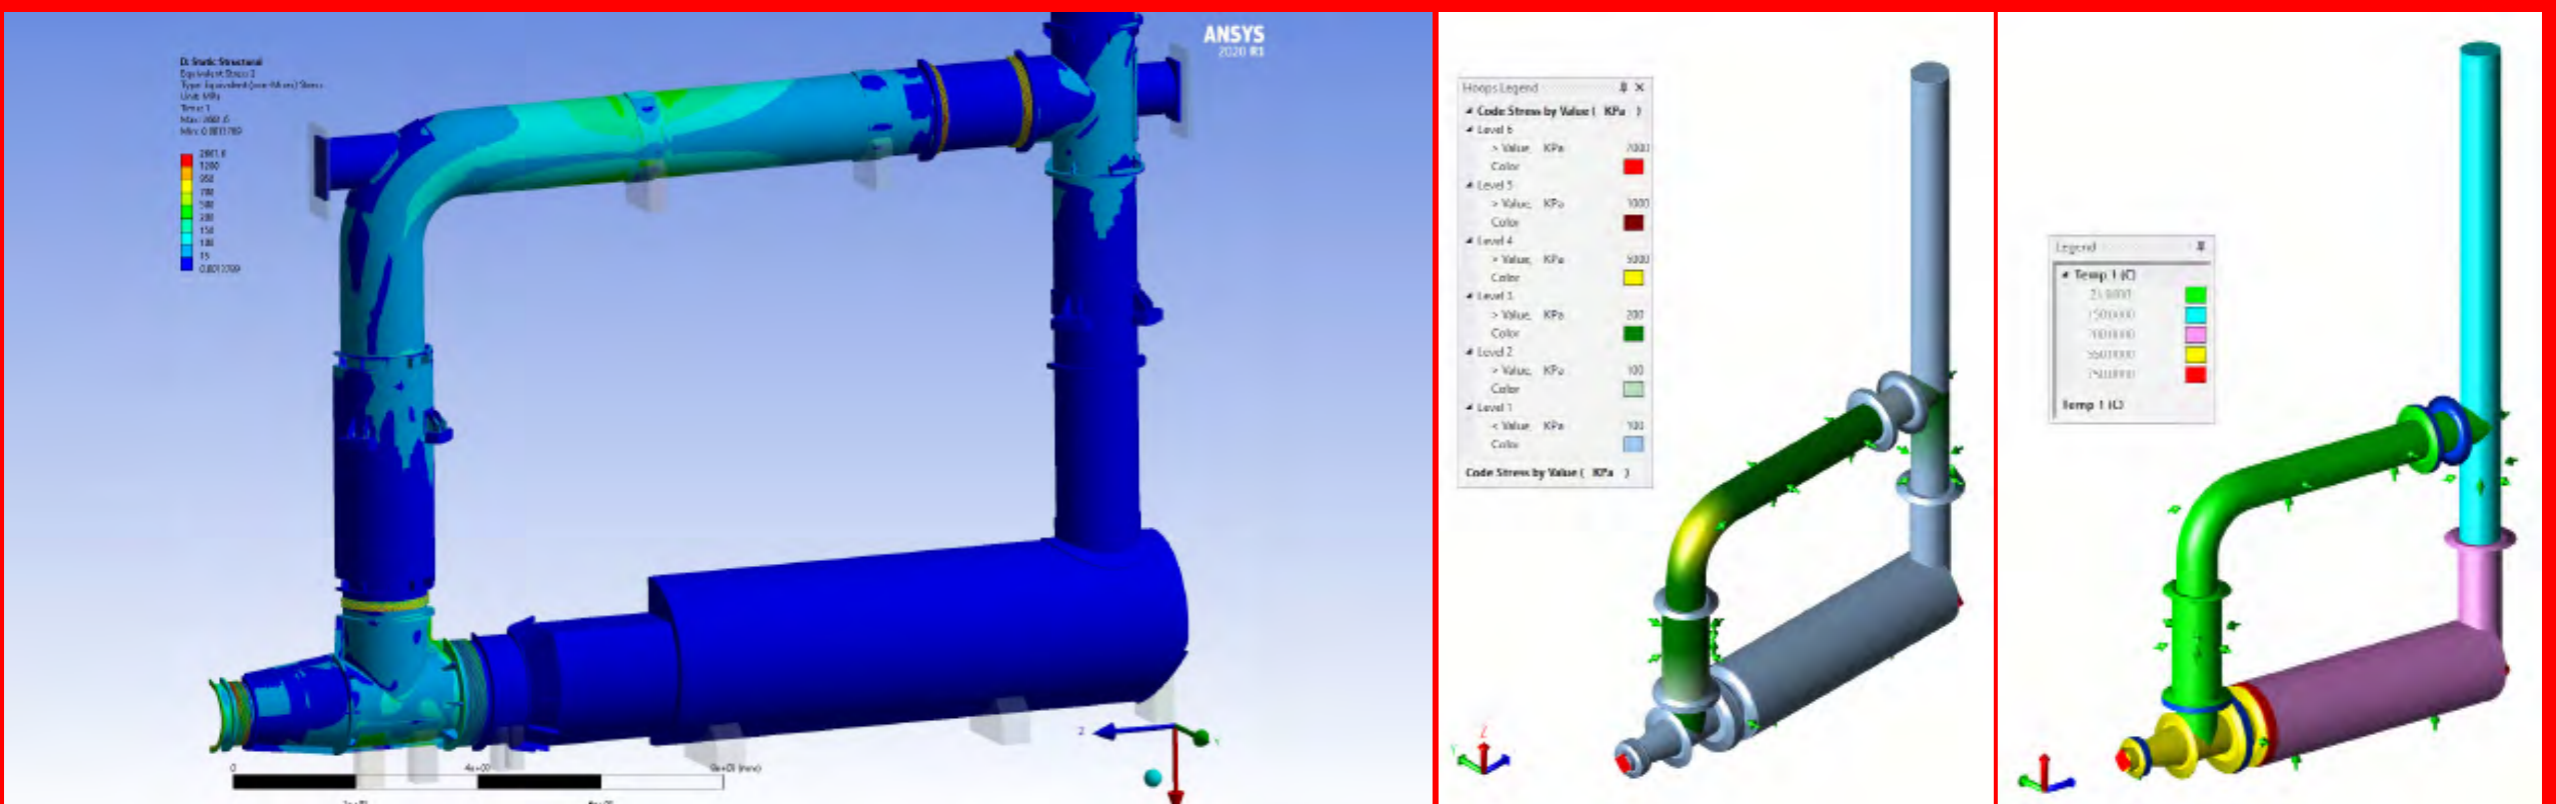
2

GEA Engineering Consulting studied the turbine exhaust duct, beginning with a stress analysis using the Caesar II software, followed by a finite element analysis of the most critical and stressed points using the ANSYS program. All input data and connected equipment were taken into consideration.

Due to the extremely high temperatures (over 700°C), GEA Engineering Consulting had to carefully study the placement and type of expansion joints to be installed, as well as the positioning of fixed points and supports. This was done to ensure that the stresses caused by the temperature remained within the allowable limits set by regulations, in order to prevent breakages during the plant startup phase.
